Part Number 1020

2002-06 Nissan Altima 2.5L
 2002-06 Nissan Sentra 2.5L SE-R & SE-R
 SPEC V
 2003 Nissan Sentra 2.5LE
 2004 Nissan Sentra 2.5S

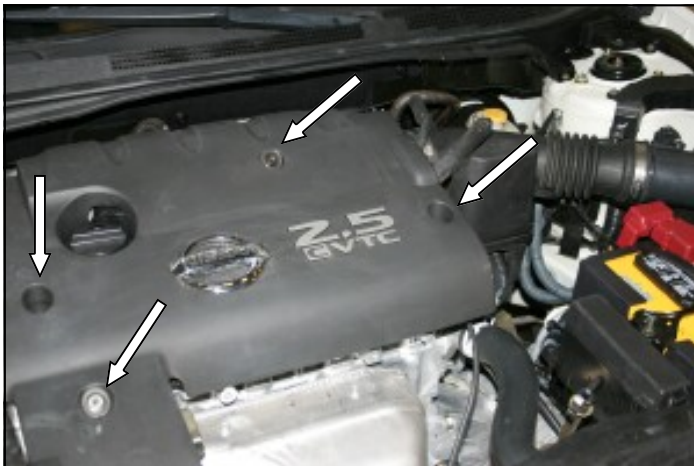
1. Disconnect the negative battery cable!

Using a 5mm Allen wrench remove the 4 Allen bolts that secure the beauty cover to the engine. Remove the cover and set it aside.

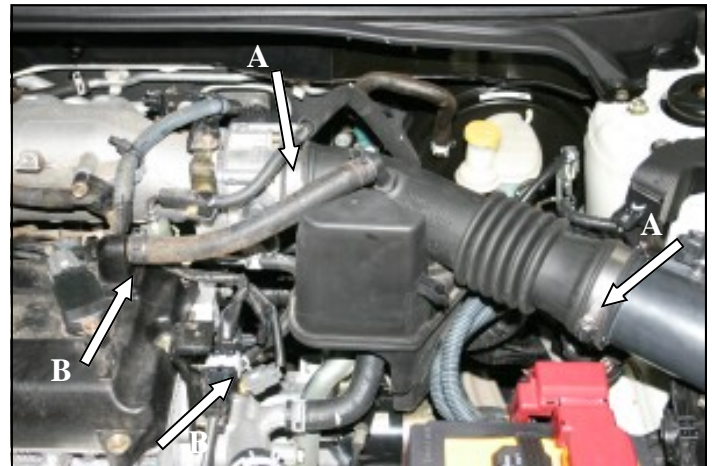
2. A.) Loosen the two hose clamps that secure the air intake tube between the air cleaner box and the throttlebody. B.) Using pliers, squeeze the hose clamp that secures the crankcase breather hose to the valve cover and slide it up the breather hose so it won't get lost. Remove the intake tube assembly and set it aside.

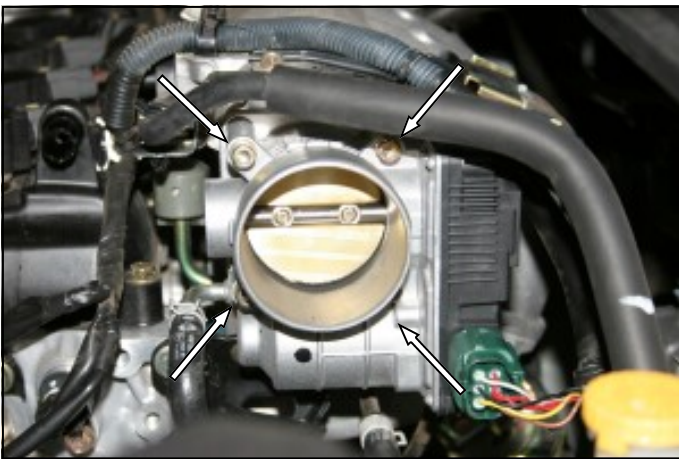
3. Remove the 4 bolts that secure the throttlebody to the intake manifold. Remove the throttlebody from the intake manifold and remove the old gasket.

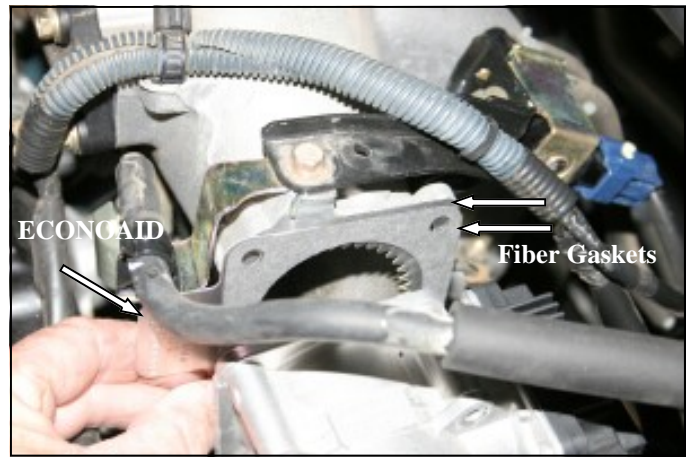
4. Install one of the supplied gaskets on each side of the ECONOAID Throttlebody Booster and then install the ECONOAID between the intake manifold and the throttlebody making sure that the logo is facing the throttlebody.

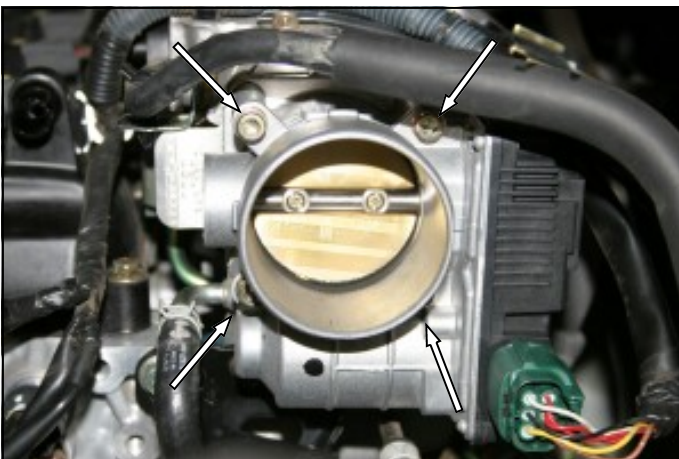
5. Reinstall the throttlebody onto the intake manifold and tighten all four bolts to the vehicle manufacturer's specifications. Before starting the engine, open and close the throttlebody to make sure there are no obstructions. Reinstall the intake tube and the beauty cover in the reverse order that they were removed.
